Fire/Smoke (Non-impact)

Serious Incident Investigation Final Report

Boeing 747-8KZF
Hong Kong International Airport
Hong Kong
29 March 2018

01-2020

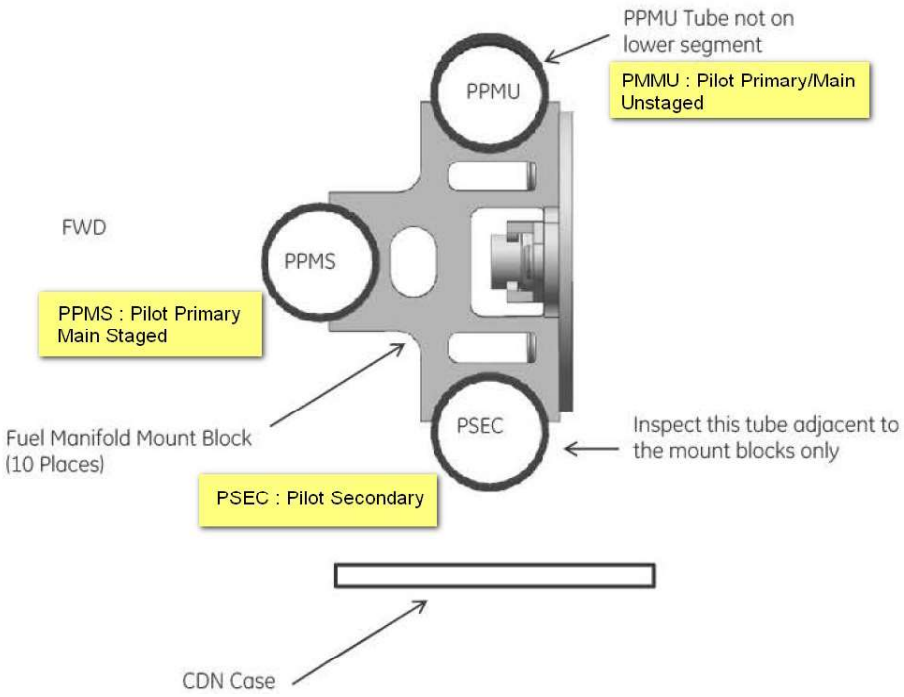
Figure 3: Cross-Section View of the Mounting of the Fuel Tubes

Defects were found in the Psec fuel manifolds adjacent to the support blocks on the GEnx-2B engines, which could lead to fuel leaks during operation. The investigation identified that the fuel manifold support brackets do not allow sufficient clearance to account for thermal expansion and contraction in the fuel manifold system.

It provides new fuel manifold system hardware to address the above-mentioned fuel manifold cracking issue. Installation of the new hardware is a terminating action to the field inspection per SB 73-0034. With installation of this new hardware, there is no further need to perform ultrasonic inspection of the fuel manifolds.

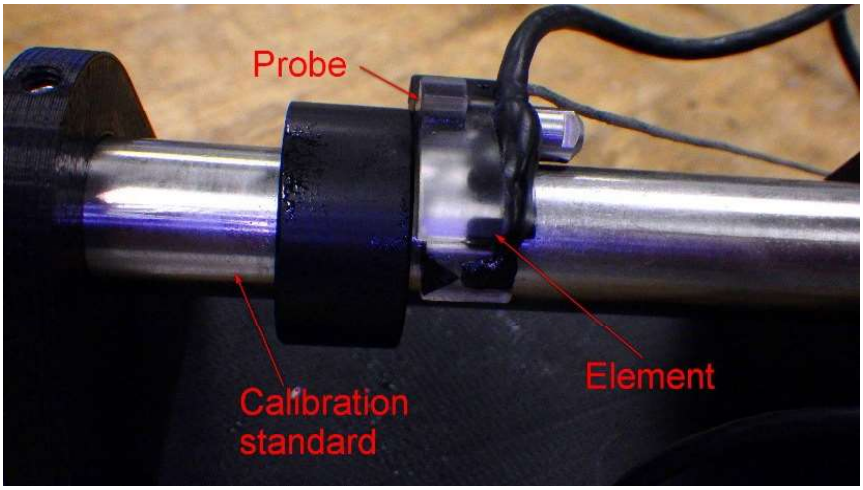
Figure 7: Probe and Elements

The probes are wrapped around and manually rotated on the fuel manifolds. They direct 70° shear waves toward the areas to be inspected. The P/N 389-085-151 probe is positioned on Psec clockwise (CW) side while the P/N 389-085-161 probe was on the counter-clockwise (CCW) side. Revision 03 of the SB introduced new P/N probes, namely P/N 00-010012 as alternative to P/N 389-085-151, and P/N 00-010013 to P/N 389-085-161.

Probe S/N 16F00EXC, which was used in the last two inspections, calibrated properly and all four elements were functional and able to resolve the EDM Notch target in the calibration standard. No electrical noise or issues were observed during the calibration routine. However, when the probe cable was put under a small amount of strain, similar to as when being used on-wing, the response from the EDM Notch became intermittent when using the No.1 and No.2 elements. No electrical noise or issues were observed when using elements No.3 and No.4. Visual inspection under 10x revealed exposed copper wires where the cable was potted in the probe body.

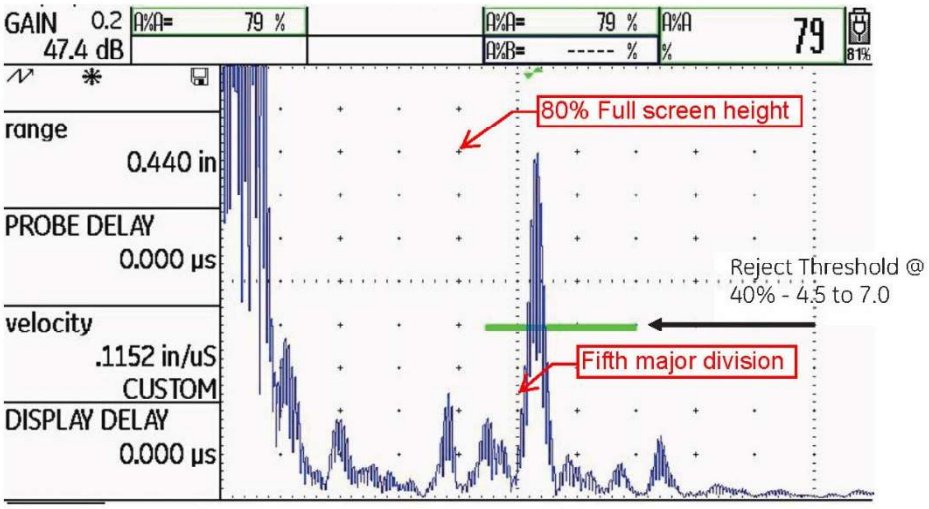
Figure 8: Inspection Range of Echo and Reject Threshold

The probes are calibrated to specific inspection range of echo and rejection level or reject threshold (represented by the green line in Figure 8). These settings were amended in the Revision 02 and Revision 04 of the SB. Revision 02 of the SB was issued to move the reject threshold from 40% to 60% due to two false manifold removals, the range of echo was not changed. Revision 04 of the SB reduced the range of echo to completely ignore indications from braze lack of fusion. The rejection level was moved back to 40% to increase inspection sensitivity.

Note: If an echo reflected from a flaw has an amplitude of 50% FSH, it will be classified a crack if the rejection level is 40% FSH, but ignored if the rejection level is 60% FSH.

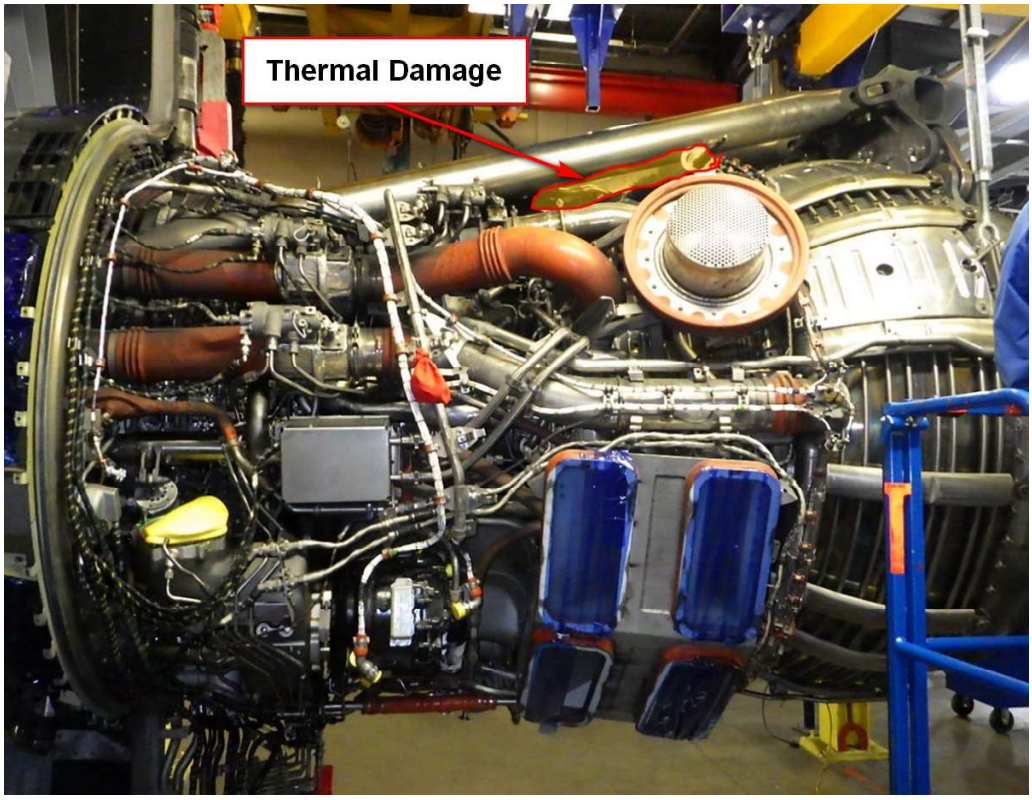
Photo 1: Thermal Damage on the Left Hand Side

Thermal damage was found at the Aft Fire Loop grommets at 11:30 to 12 o'clock position, and discoloration at the underside of the LH Thrust Link. In addition, sooting was noted in some locations forward of the manifold. Thermal distress on the fire loop grommets in the same clock position as the second upper braze block of the manifold were also observed. Melting of grommet material is an indication of temperatures in excess of approximately 510 degrees Celsius.

Photo 2: Melted Grommet Materials

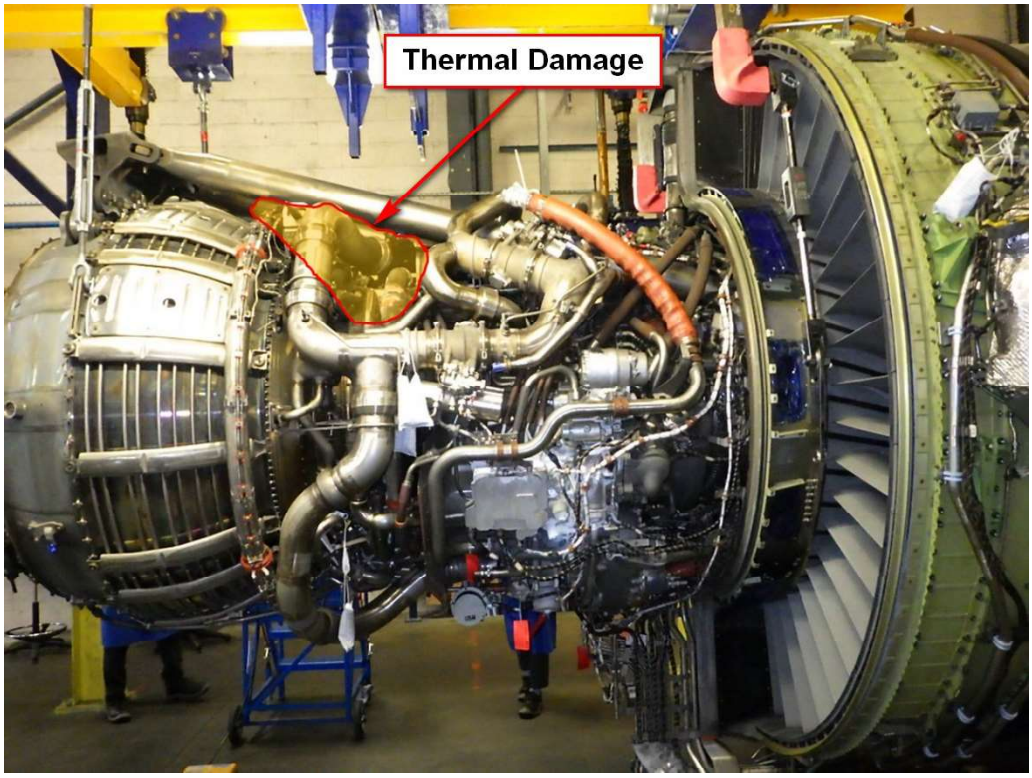
Photo 4: Thermal Damage on the Right Hand Side

Thermal damage was also found at the Aft Fire Loop grommets at 12 to 12:30 o'clock position and the applied RTV Seals on the High Pressure Turbine (HPT) Active Clearance Control (ACC) Cooling Ducts at 12 to 2 o'clock position. Discoloration was observed at the underside of the right hand Thrust Link.

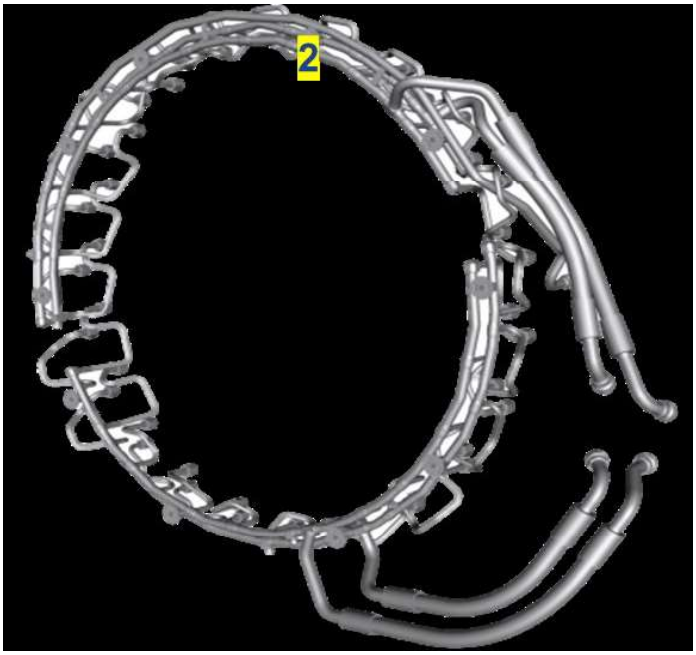
Figure 9: The Second Upper Braze Block

During the investigation at GE Caledonian, with the top manifold (part number 2561M11G01) still installed, a 50 psi air pressure test leak check was conducted and soapy water was applied to the second upper braze block area. Isolated bubbles were observed from this area.

Photo 6: Isolated Bubbles from the Second Upper Braze Block Area

The manifold was removed, placed in a water bath, and pressurised with Nitrogen at 10 psi. Blowing bubbles were noted at the same block area. It was confirmed that a crack existed on the Psec manifold at a location next to the second upper braze block.

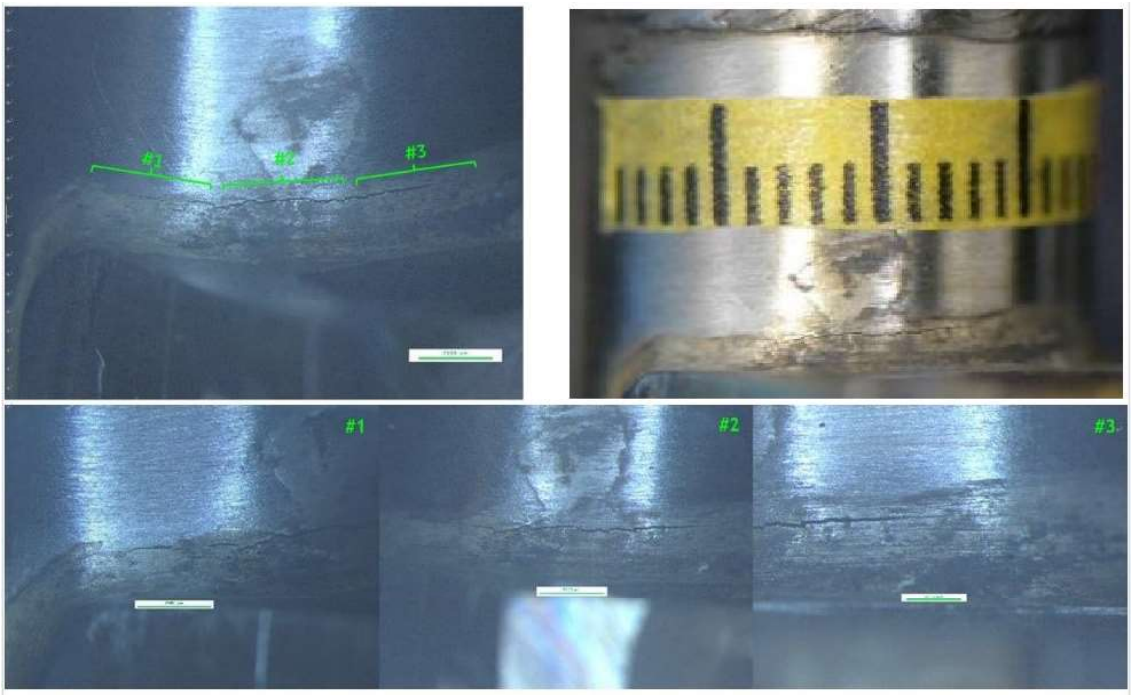
Photo 8: Crack Adjacent to the Second Upper Braze Block

The manifold was later sent to GE's material laboratory in Shanghai. The Scanning Electron Microscopy (SEM) techniques were applied for extensive observation of the fracture surface of the crack for its initiation and the fatigue striations away from the initiation. Cracking was identified in the tube adjacent to the second upper braze block and it extended along the welding toe of the brazing joint.

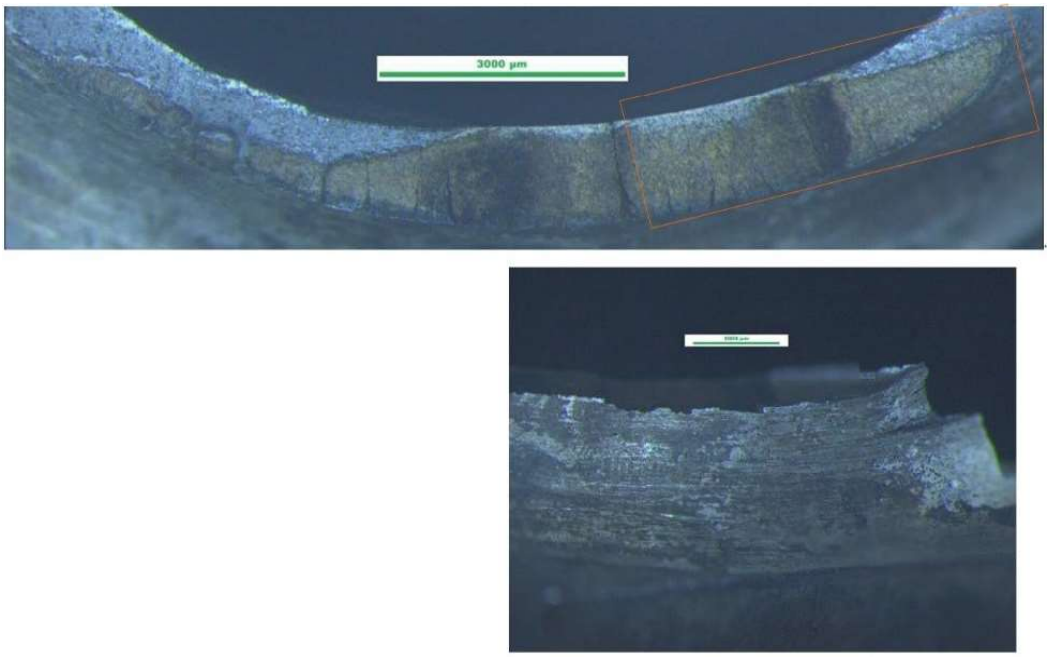
Photo 9: Fracture Surface

Examination of the fracture surface revealed that the crack had multiple initiation sites on the outside diameter (OD) side of the manifold. The fatigue crack extended through the thickness of the wall. Fuel leak was evident from the deposit left on the fracture surface, which was heavily oxidized. The fracture morphology was consistent with high stress low cycle fatigue propagation.

During the fatigue analysis, Energy Dispersive Spectroscopy (EDS) was performed on the fracture surface. It was confirmed that the spectrum was consistent with 321 stainless steel. The cut-up section through the crack origin showed that the crack propagated in transgranular mode and no microstructure anomaly could be found. The crack initiated

from the OD side and propagated through the ID side of the tube. The fracture morphology was consistent with crack propagation at high stress and low cycle fatigue (LCF). The striation density was estimated at multiple distances from the origin and the results were consistent with LCF propagation.
